Different Problems faced and Changes Implemented for Powerhouse Cavern

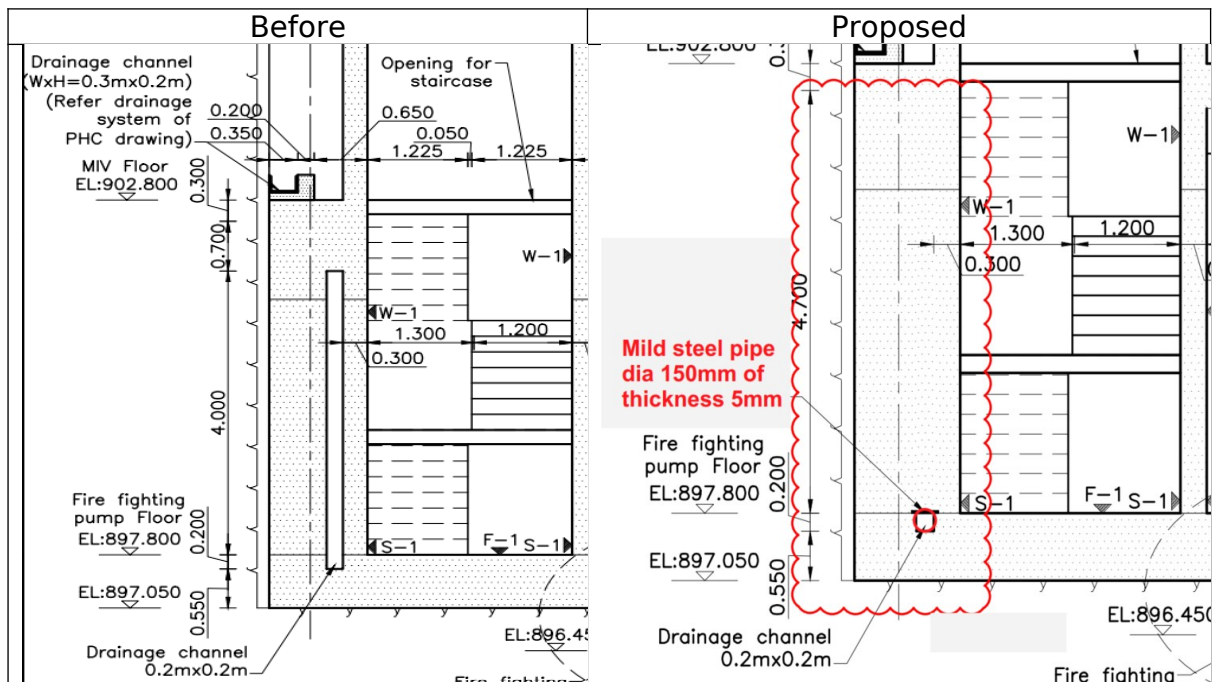
1. DCN-24-C-001: Date 01 Jan 2024, due to the Construction Teams requirement i.e. difficulty in formwork execution behind the Shear Wall of Staircase of Bay 01 Draft Tube Floor, the 20cm gap was decided to fill with concrete. The Drainage Trench was also decided to be replaced by Mild-Steel Pipe of Dia 150mm.

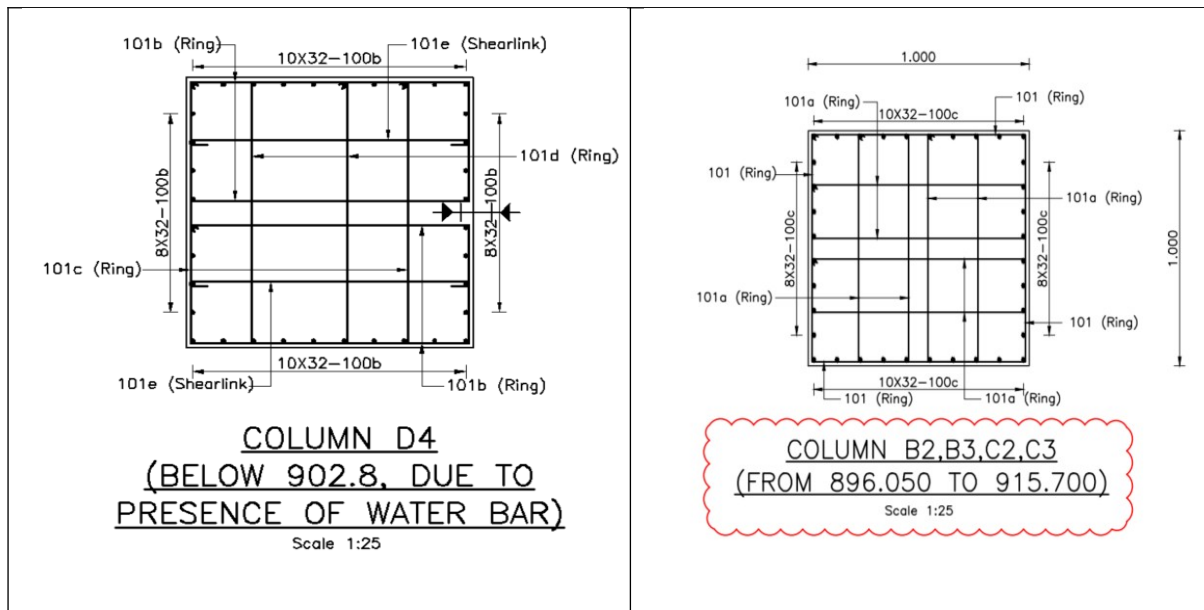
| Previous revision | Updaetd |

2. Before, it was planned to install the WaterStop at the Column D4 of Bay 01 and Column D5 of Bay 02, but after it was recommended no necessity of Waterstop at those area by Doosan Team Member. So Waterstop was removed from the drawing of both Bay 01 and Bay 02 of respective column and was also not installed at site.

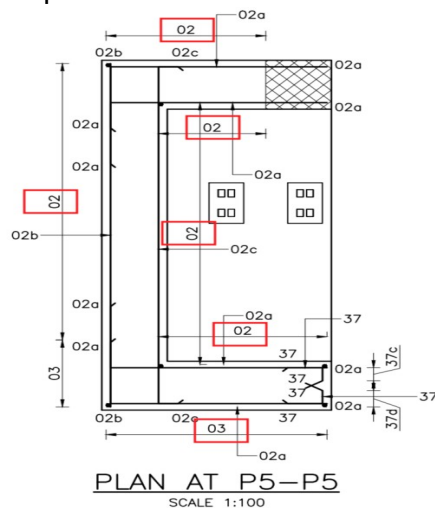
3. Bay 02, Reinforcement Drawing Below 902.8amsl Rev.0C: In the Drainage Slump, Rebar 02 and 03 (Vertical Wall rebars) were submitted with development with 300mm. The BBS had already been implemented at site. But in the revised drawing from Sanima for same Rev.0C (with no revision cloud mark), same rebars were given 1250mm development in BBS which gave the problem at site. As OE people had the new revised drawing, Rebar 02 and 03 had to be replaced as per new BBs i.e. 1250 Development Length.

Also, 1m width wall on the face of Drainage gallery of Bay 02 had no closing rebar in the previous Drawing provided by Sanima. In the revised drawing, this mistake was also corrected and was implemented at site.

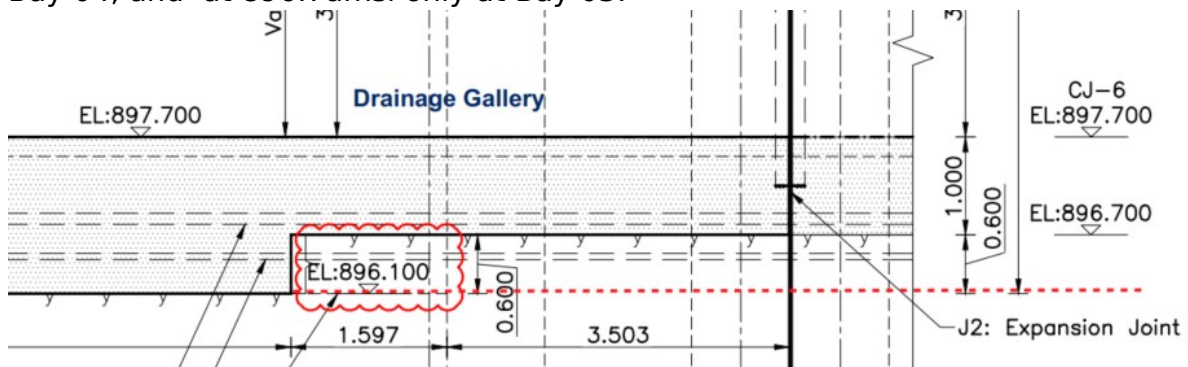
4. As per our Excavation Status of site and Excavation-Support Drawing of PH, Drainage Gallery had to build on different Elevations, 896.1amsl and 806.7amsl at different section. It was to be built at elevations 896.1 & 896.7 at Bay 02 & Bay 04, and at 896.7amsl only at Bay 03.

But Sanima designed the Model at only elevation 896.1amsl and provided drawing of Drainage Gallery for only 896.1 amsl. So, PC instructed Sanima so change the drawings based on the present Excavated Site condition of PHC. We have already got the updated drawings for PH Bay 02, but the Structural Calculations has not been updated and provided to PC till date.
